Paramotor Li-Po battery fire

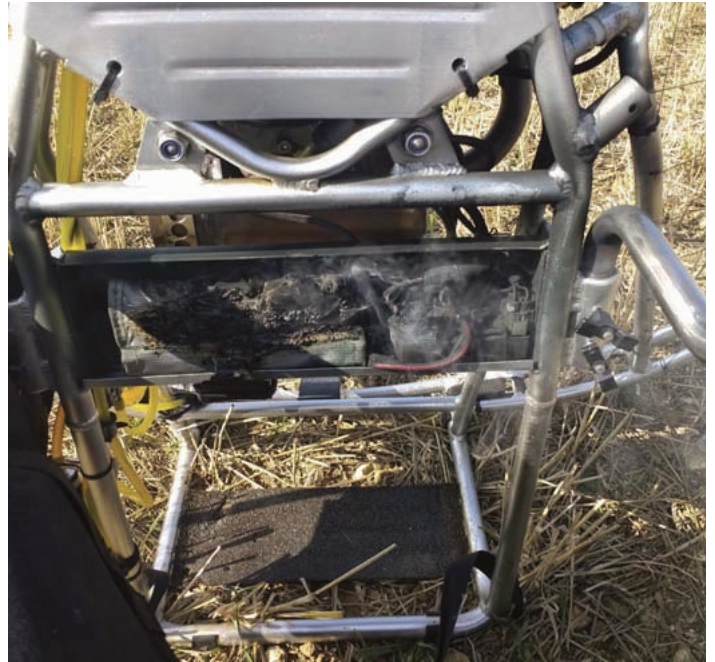
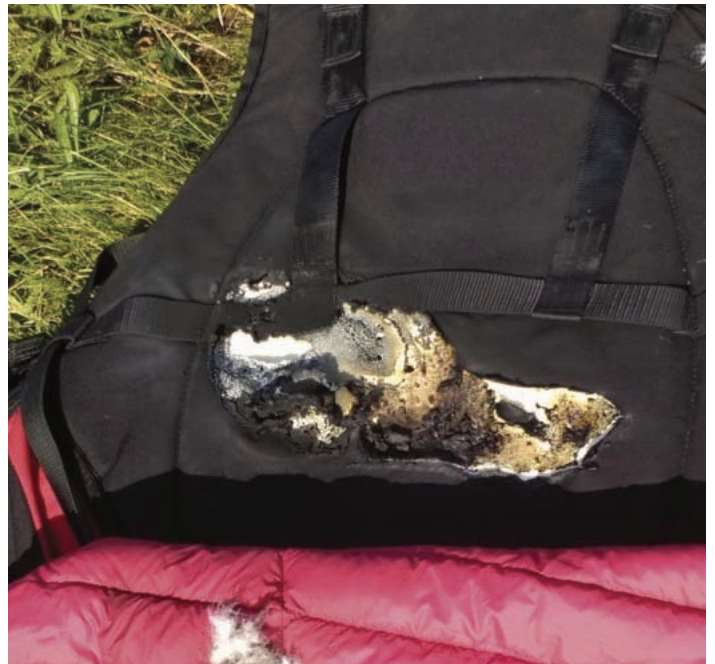
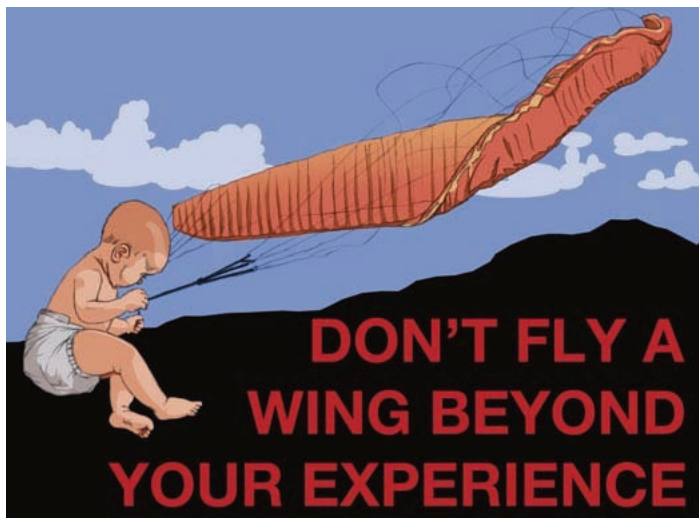
A BHPA member recently reported experiencing a fire in flight on their paramotor. The pilot managed to land safely but discovered that the fire had burned his harness and insulated jacket. The Lithium Polymer (Li-Po) battery fitted to the paramotor's electric starting system (which incorporated a charging circuit for a non-Li Po battery) had caught fire and burned through its 'fireproof' bag. The battery had been retro-fitted to the charging circuit by a previous owner, who had replaced the manufacturer-supplied non-Li Po battery with a Turnigy Nano-Tech Li-Po battery.

Even a battery that has not been dropped may 'pillow', a condition where the internal components of the battery break down and swell, causing the external casing to expand like a pillow. The pillow shape indicates battery failure which may lead to rupture and fire. The battery should not be used but disposed of in accordance with the manufacturer's guidance. A Li-Po/Li-ion battery that is subjected to a forceful impact may present a significantly greater risk of becoming involved in fire.

If your engine is fitted with a charging circuit for a non-lithium based battery (eg lead-acid or NiCad), do not fit a lithium-based battery (e.g. Li-Po, Li-ion) without first consulting your power unit's manufacturer. Lithium based batteries can become a fire risk without circuitry specific to the battery type.

In respect of general battery care we reiterate our message from January 2020 Skywings – if you have a Li-Po battery used for electric start or for strobes, it must form part of your Daily Inspection. If you have had a previous heavy landing on your powered hang glider or paraglider equipped with a Li-Po/Li-ion battery, you are urged to check the battery for obvious signs of damage.
