## **Copy of Safety Notice Issued by Advance**

### **SAFETY NOTICE**

Reserve handle check is required for PROGRESS 3 & EASINESS 2 harnesses

## Instructions for the PROGRESS 3 and EASINESS 2 reserve parachute handle check

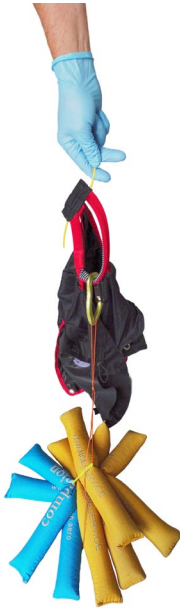
1. Pull the reserve out of the harness.	
2. Take the reserve parachute out of its inner container.	
3. Attach the weight 10-12 kg to the reserve handle by a carabiner and/or line.	
4. Put on a glove so that the yellow cable does not slip out of your hand, grasp it on one side of the handle and lift it until the entire weight is lifted from the ground.

<p>1. The cable must not have any play or be able to be moved off centre. A minimal movement of approx. 2 mm is permissible due to the elasticity of the fabric.</p>	
<p>2. If the cable can be pulled out on one side and not on the other, the handle and container must be replaced.</p>	
<p>3. If the cable can be moved such that its sewing or threads are visible or frayed, the handle and container must be replaced without question.</p>	
<p>4. Replace the container if you are not sure. This applies for any uncertainty, if you suspect point 2 or 3 or the test is inconclusive.</p>

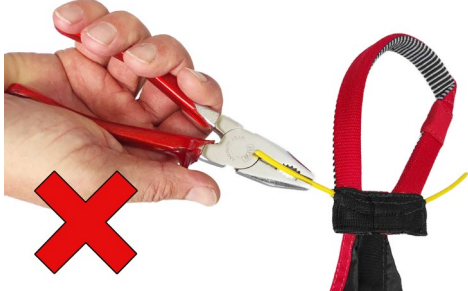
5. Repeat step 4 with the yellow cable on the other side of the handle..	
<p>IMPORTANT: The yellow cable must not be gripped with pliers or similar metal devices. This can damage its smooth surface and jamb subsequent releases.</p>
